Service Alert

| Subject: MAZDA CONNECT CENTER DISPLAY CRACKING (SPIDER CRACKING) | Service Alert No.: SA-008/18 |
| | Last Issued: 02/20/2018 |

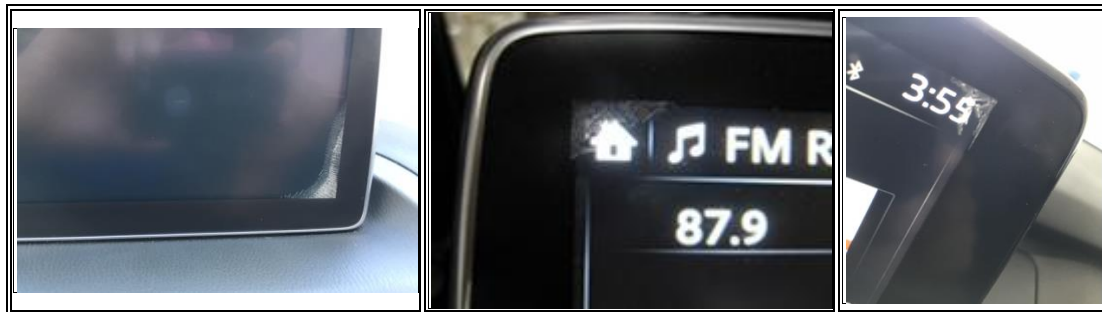
Some customers may complain about the MAZDA CONNECT center display cracking (spider cracking). The cracks are internal and cannot be felt by touch. This may be caused by a faulty center display.

1. Verify customer concern.
2. Replace the MAZDA CONNECT center display. Refer to MGSS online Workshop Manual CENTER DISPLAY REMOVAL/INSTALLATION.
3. Verify repair.
